# Penn Presbyterian Medical Center, Philadelphia, USA

CDM-MONT

Project Reference

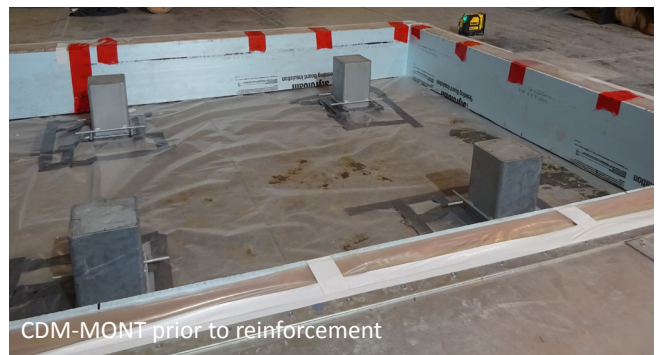
CDM-MONT prior to reinforcement

- CDM installed a CDM-MONT solution with 2.5 Hz spring isolators in a 10" floating concrete slab. The floating floor was jacked to create an air gap of 2".

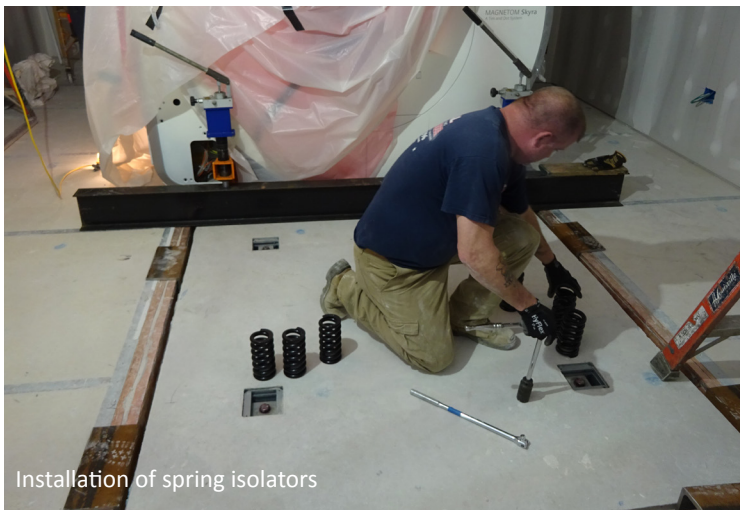
Installation of spring isolators

- Thanks to an in-house finite element analysis, CDM could design the special springs needed to guarantee the specified isolation performance with minimum differential deflection and tilting of the MRI equipment, while coping with the eccentric loading.

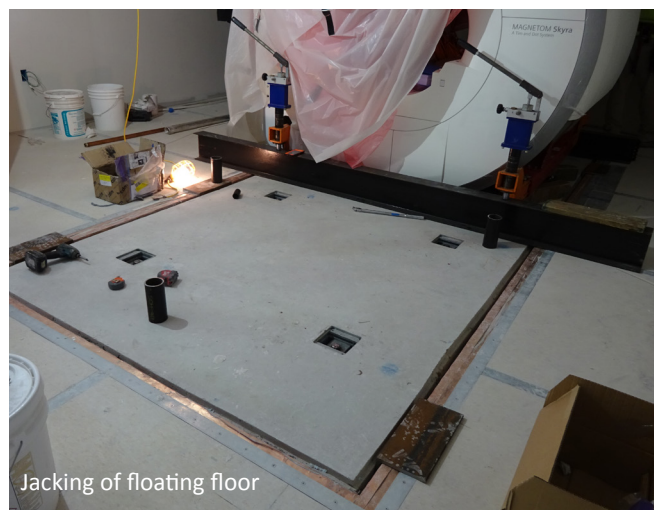
Jacking of floating floor
